DEPARTMENT OF TRANSPORTATION

Quality Assurance and Source Inspection

Contract #: 04-0120F4Cty: SF/ALA Rte: 80 PM: 13.2/13.9File #: 99.28**WELDING INSPECTION REPORT****Resident Engineer:**Pursell, Gary**Address:** 333 Burma Road**City:** Oakland, CA 94607**Report No:** WIR-012363**Date Inspected:** 29-Jan-2010**Project Name:** SAS Superstructure**OSM Arrival Time:** 645**Prime Contractor:** American Bridge/Fluor Enterprises, a JV**OSM Departure Time:** 1845**Contractor:** Zhenhua Port Machinery Company, Ltd (ZPMC) Chanxing Island**Location:** Shanghai, China**CWI Name:** N/A**CWI Present:** Yes No**Inspected CWI report:** Yes No N/A**Rod Oven in Use:** Yes No N/A**Electrode to specification:** Yes No N/A**Weld Procedures Followed:** Yes No N/A**Qualified Welders:** Yes No N/A**Verified Joint Fit-up:** Yes No N/A**Approved Drawings:** Yes No N/A**Approved WPS:** Yes No N/A**Delayed / Cancelled:** Yes No N/A**Bridge No:** 34-0006**Component:** OBG Segment 8CE**Summary of Items Observed:**

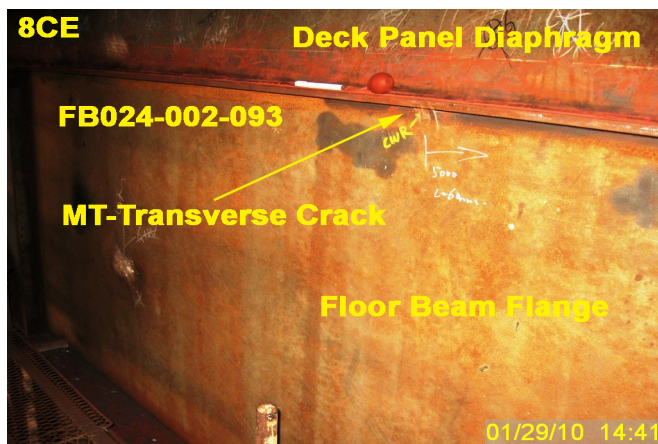
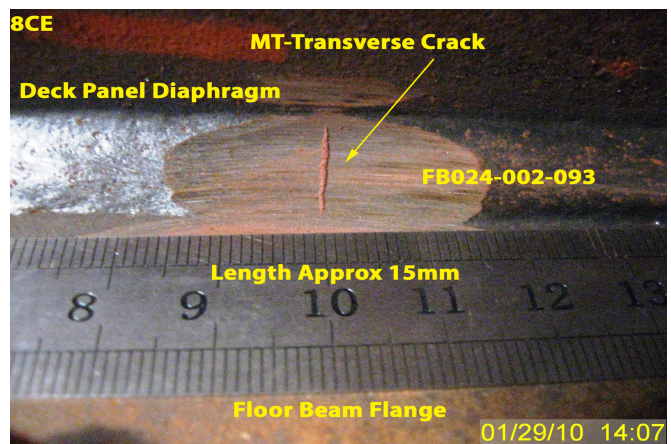
Description of Incident: During random Quality Assurance Visual review of welds located on segment 8CE, this Quality Assurance Inspector (QA) discovered 15mm long Transverse Indication in Floor beam Web to Flange weld. The indication were discovered visually and confirmed by Magnetic particle Testing (MT) by Caltrans QA. The weld is identified as FB024-002-093 and Indication from "Y" location is 5000mm. The Panel Point number is identified as PP69 on OBG Segment 8CE. This weld is designated as Seismic Performance Critical Member (SPCM) and ZPMC Quality Control Personnel have performed 25% Magnetic Particle Testing of this weld. For further information, please see the attached pictures.
